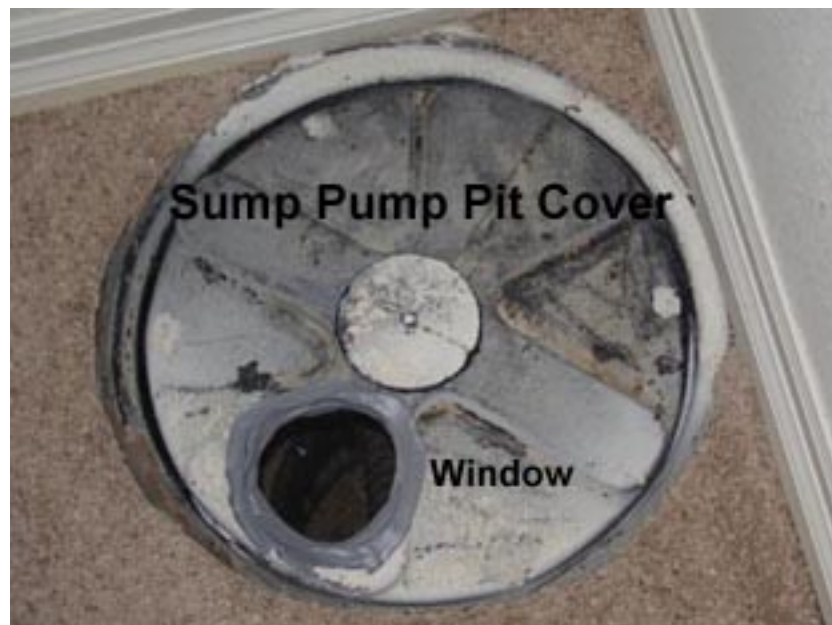
Sump Pump Pit:

We have never had any flooding. They glued a little window into the Sump Pump Pit Cover and then sealed the Cover in place. In a rainy period, we can shine a light into the little window and assure ourselves that there is no water accumulation. The continuous Radon venting helps prevent the water accumulation.

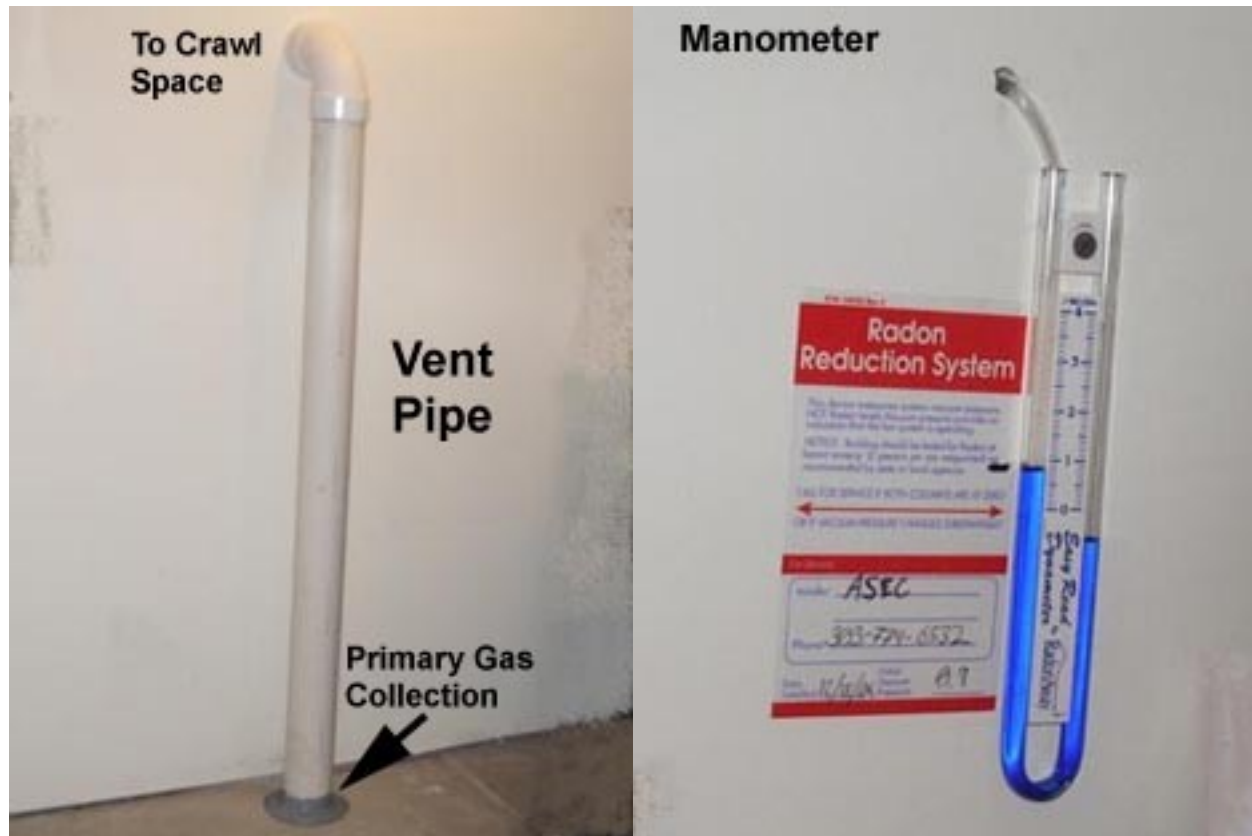
Basement Floor:

The primary gas collection is through the basement floor. They drilled a hole through the concrete, removed soil to create the required open space under the floor. They sealed in a vent pipe connected to the Radon ventilation system. In our house the vent pipe is routed through the crawl space and out through the garage, through the attic and out a roof vent. The ducting is 4.5 inch outside diameter PVC drain waste and vent pipe.

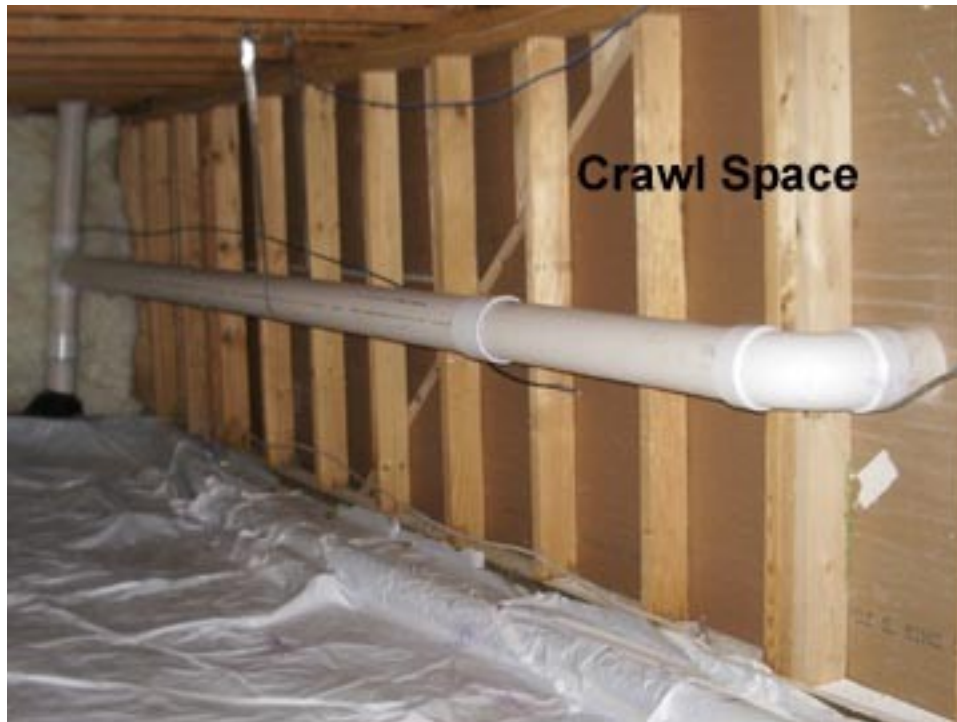
4-5 inch diameter corrugated and perforated flexible plastic ducting will be placed around the periphery and plumbed in to the Radon venting system.

A very tough plastic sealing membrane will be sealed to the concrete foundation with construction adhesive.

The manometer indicates if the system is maintaining the required vacuum under our house. Loss of this pressure differential would indicate pump failure or leakage in the sealing membrane and time to call the contractor.

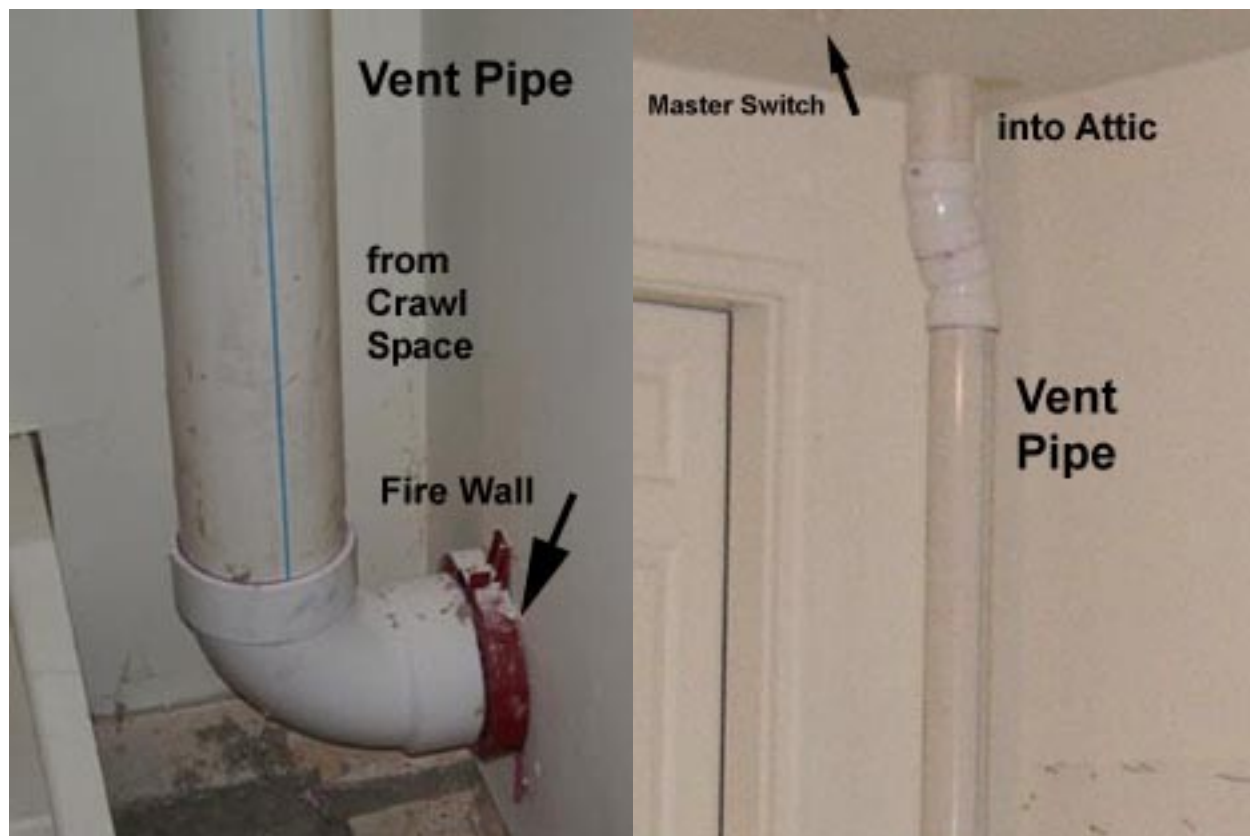
Exhaust Vent:

The collected gas is vented above the roof line to prevent its reentering the home. Some homes have it vented at the side of the house through an 'up spout'. In our case, we selected the option to have the ducting run through the garage, through the attic and out through a roof vent.

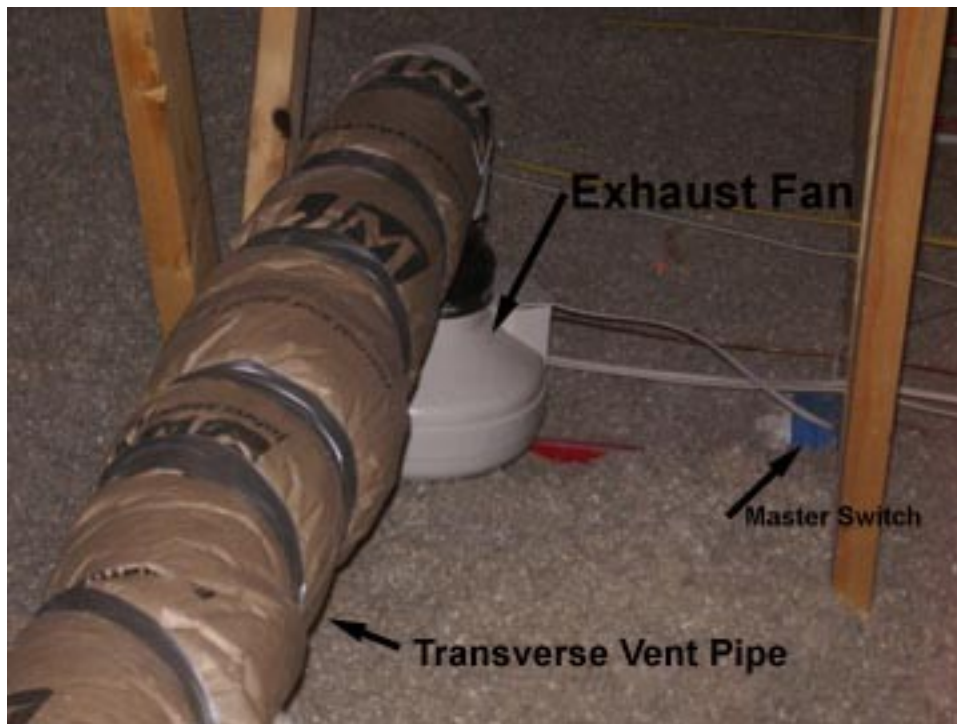
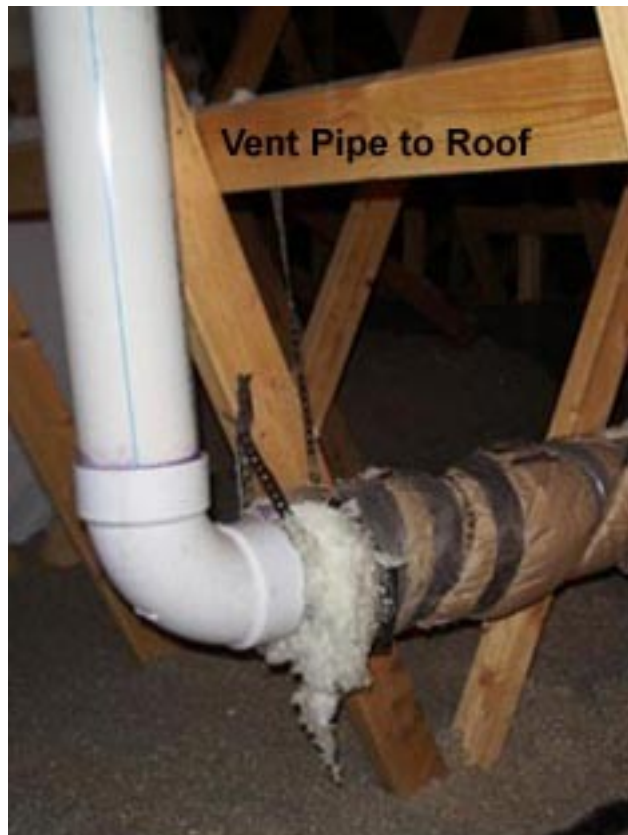
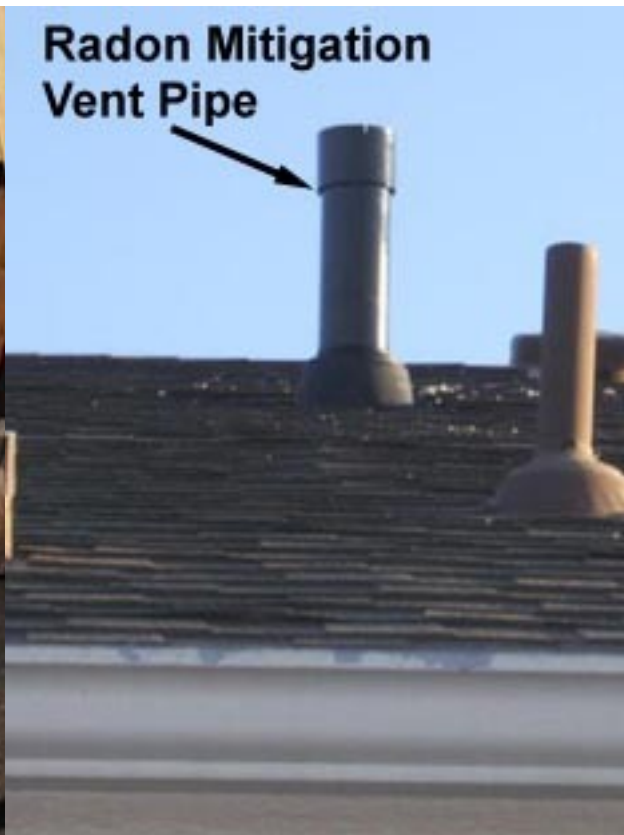
**Exhaust Fan:**

The Exhaust Fan is located in the attic. It is wired with a master switch mounted in the garage ceiling. Our fan is quieter and is a higher quality than many. It cannot be heard from any of the bedrooms nor the outside. A soft hum can sometimes be heard, however, from the Bedroom closet that has an attic trapdoor and also may be heard from the hallway. After a rainy period, the fan works harder to pump out the added moisture and is noisier for a while. When dryer weather returns, it quiets back down. I wonder if it is realistic to mount it to the attic trusses with vibration isolators so it could not be heard at all? I do not think anyone else has ever noticed any sound from our Radon mitigation system. The transverse duct in the attic is insulated to prevent any water vapor in it from freezing.
